DELAWARE RIVER BASIN
SALEM CREEK, SALEM COUNTY
NEW JERSEY

MUNSON DAM

NJ 00118

PHASE 1 INSPECTION REPORT NATIONAL DAM SAFETY PROGRAM

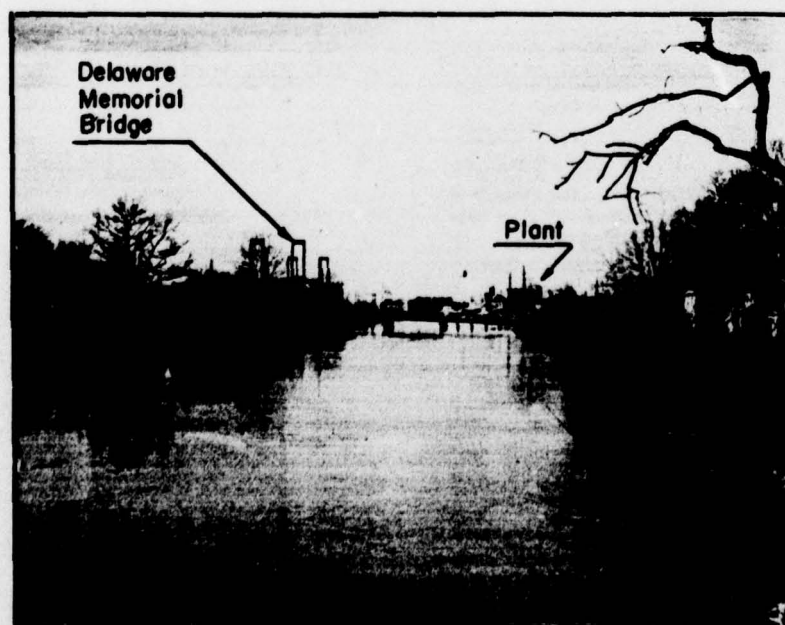
View West along canal towards Chambers
Works Plant

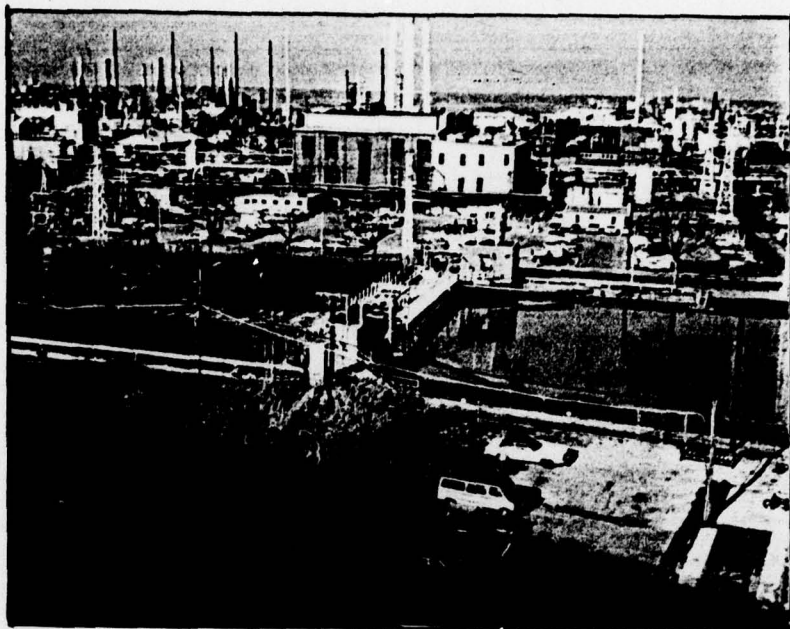
View of Munson Dam from Delaware Memorial Br.
